**DEPARTMENT OF TRANSPORTATION**

Quality Assurance and Source Inspection

Contract #: 04-0120F4Cty: SF/ALA Rte: 80 PM: 13.2/13.9File #: 69.28**WELDING INSPECTION REPORT****Resident Engineer:** Pursell, Gary**Address:** 333 Burma Road**City:** Oakland, CA 94607**Report No:** WIR-016000**Date Inspected:** 29-Jul-2010**Project Name:** SAS Superstructure**OSM Arrival Time:** 700**Prime Contractor:** American Bridge/Fluor Enterprises, a JV**OSM Departure Time:** 1900**Contractor:** Zhenhua Port Machinery Company, Ltd (ZPMC), Changxing Island **Location:** Shanghai, China**CWI Name:** Mr. Zhao Chen Sun**CWI Present:** Yes No**Inspected CWI report:** Yes No N/A**Rod Oven in Use:** Yes No N/A**Electrode to specification:** Yes No N/A**Weld Procedures Followed:** Yes No N/A**Qualified Welders:** Yes No N/A**Verified Joint Fit-up:** Yes No N/A**Approved Drawings:** Yes No N/A**Approved WPS:** Yes No N/A**Delayed / Cancelled:** Yes No N/A**Bridge No:** 34-0006**Component:** Tower**Summary of Items Observed:**

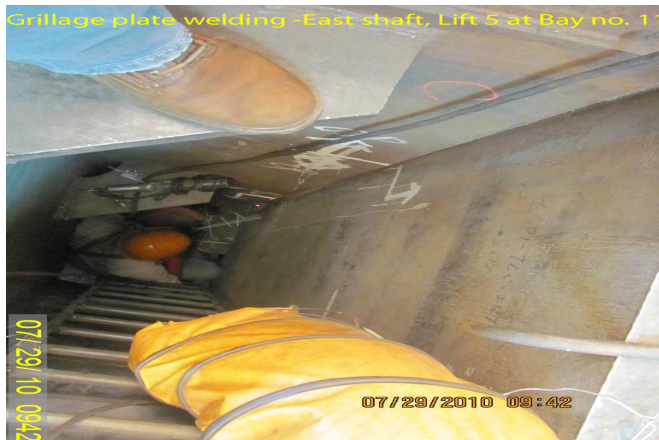
1.This QA inspector, Baskar Govindarajan, observed, ZPMC qualified welding personnel identified as 040610 perform SMAW welding on; East shaft, Lift 5, Grillage plates and the weld joint is identified as ESD1-TL5-2 B/F-13. ZPMC CWI Identified as Mr. Zhao Chen Sun. The welding parameters as measured using QC's calibrated instruments appeared to be in general compliance with WPS-B-T-3213-TC-U4c. (Photo attached)

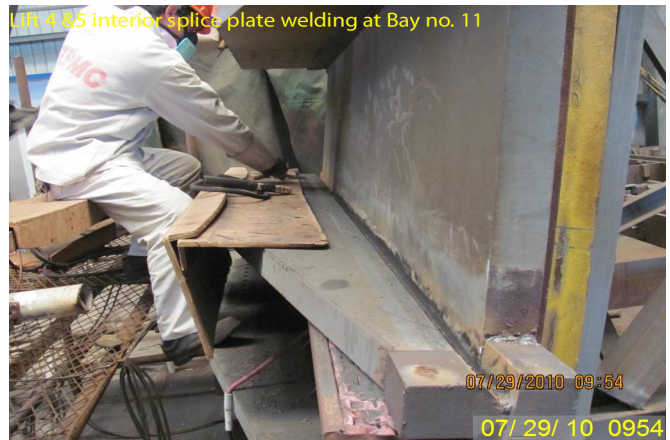
4.This QA inspector, Baskar Govindarajan, observed, ZPMC qualified welding personnel identified as 040656

perform SMAW welding on; Interior splice plate between Lift 4 & 5, and the weld joint is identified as WSD1-SPSA5-7-1A. ZPMC CWI Identified as Mr. Zhao Chen Sun. The welding parameters as measured using QC's calibrated instruments appeared to be in general compliance with WPS-B-T-3211-TC-U5B-1. ( Photo attached)
